Mine Falls Park Gatehouse

Mine Falls Nashua Manufacturing Company 1886 Gatehouse

*City Of Nashua, New Hampshire, Mine Falls Park Gatehouse
Historic Structure Report & Preservation Study*

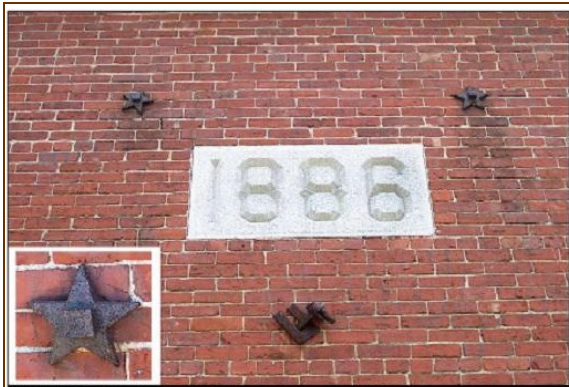
Photo No. 11: East exterior wall of Gatehouse, showing date stone, brick bond, star washers (see inset detail), and hinge pinhole remaining from former gate. Looking west.

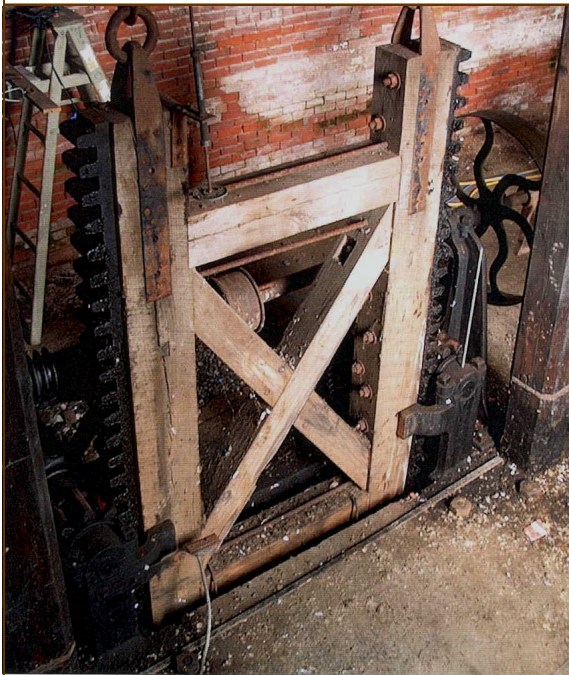
Photo No. 37: Gate # 2, showing lift frame construction, rack and pinion gears, and pinion-gear bearing stanchion and gate-guide bolted thru floor. The bolts resist any uplift forces induced by the counterweights. The lift straps and rings are original, the chains and hook are not. The counterweight is outside the building, replaced with a wood box mock-up. Looking east.

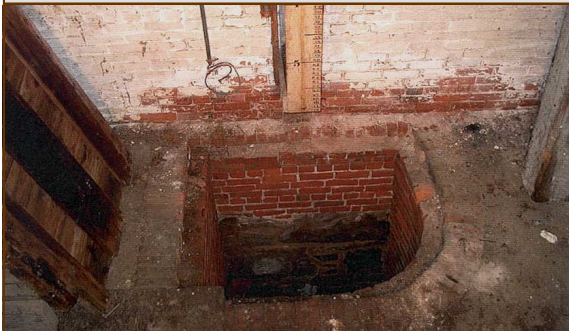
Photo No. 59: Gauging Well and Float-type Indicator. Wood well raised and leaning up at left. Note: electrical conduit and wire extending to floor believed to have connected to electrical water-level sensor in the well at one time. Looking west.

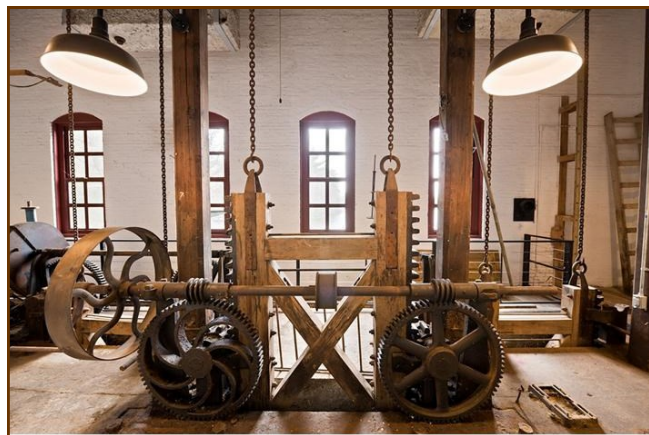
Interior of the restored Gatehouse

Improvements included interior and exterior cleaning, roof replacement, pointing and replacement of bricks; replacing windows and doors; installation of railings; replacing wooden stairs to the sluice area, updating the electrical supply while preserving the old components; installation of safety and emergency systems, and rehabilitating the mechanical furnishings in the gatehouse.

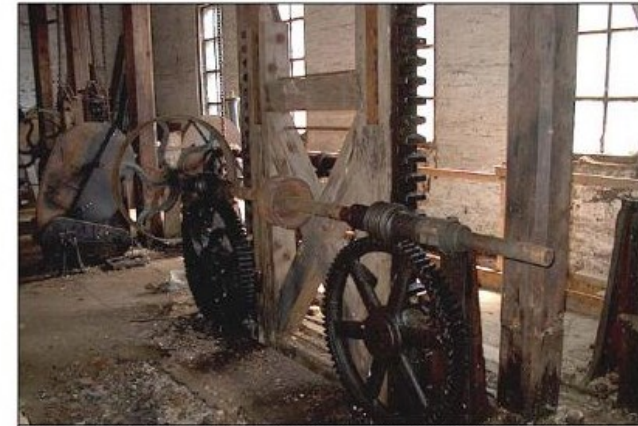
Photo No. 38: Gate # 2, showing single drive shaft with attached hand-crank, belt-drive wheels and two worm gears. The worms turn two large spur gears, that turn two pinion gears that drive the two rack gears attached to the sides of the gate lift frame, up or down. The motor chain-drive equipment is missing, apparently destroyed when the counterweight fell. Looking south.

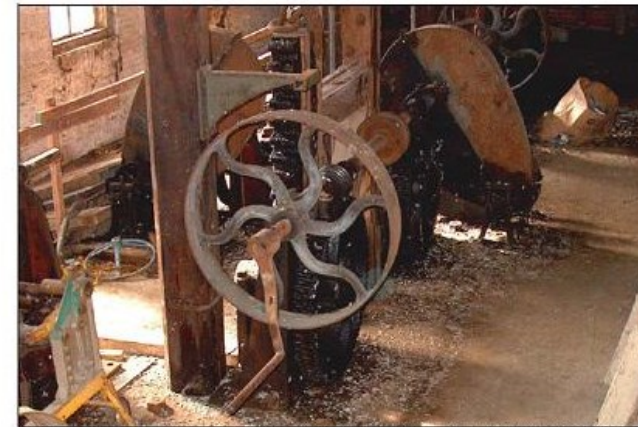
Photo No. 39: Gate # 4, showing single drive shaft with attached hand-crank, and belt-drive wheels. The angle bracket mounted on the post above the drive wheel was reportedly to engage the belt drive. The motor chain-drive equipment is attached at far end of driveshaft. Looking south.
